# Integrating Natural Hard and Soft Tissue

## An Implant-Supported Restoration in the Esthetic Zone

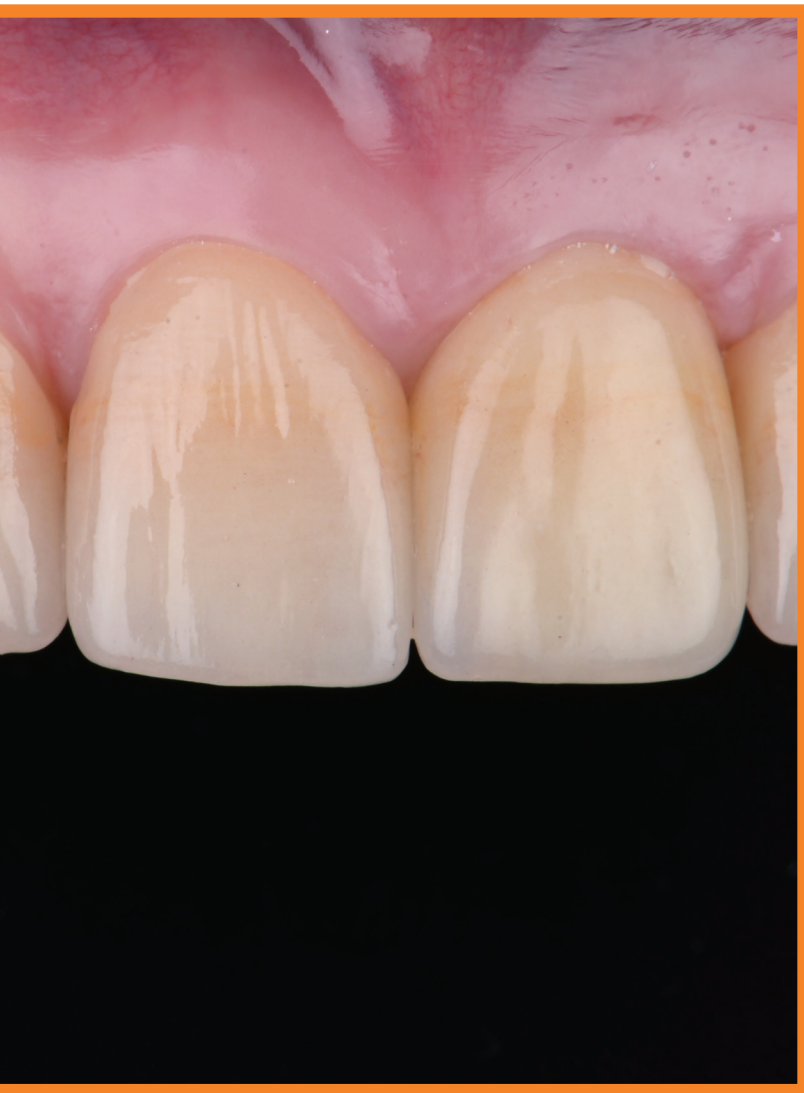
**// The successful replacement of anterior teeth with implants requires an interdisciplinary approach. //**

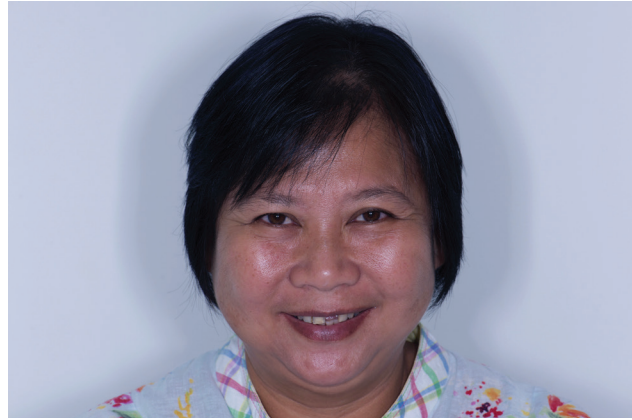
**Figure 1:** Preoperative; the patient's unhappy, unconfident smile.

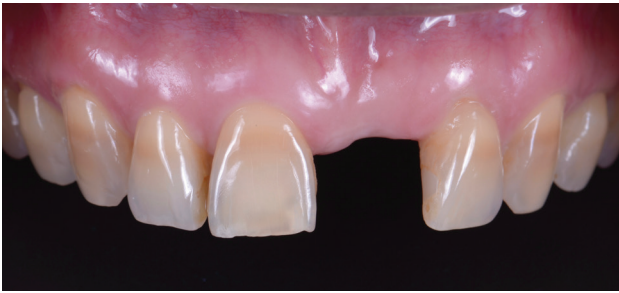
**Figure 3:** Preoperative intraoral frontal view; worn dentition and missing soft tissue.

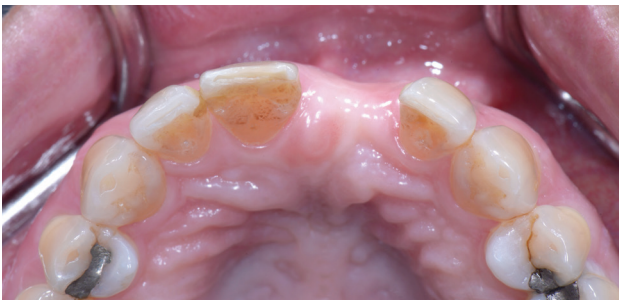
**Figure 4:** Preoperative occlusal view; medium bone resorption at edentulous area.

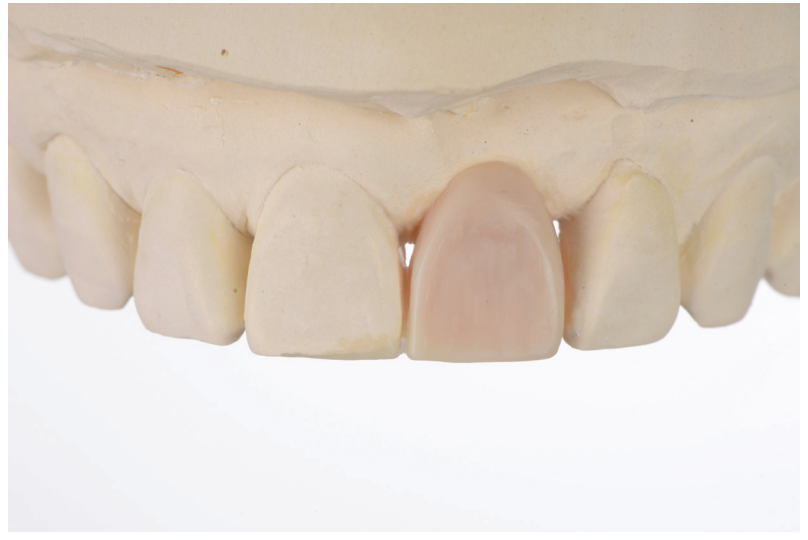
**Figure 6:** Diagnostic wax-up; this was a blueprint of the definitive restoration and also a good communication tool between team members and the patient.

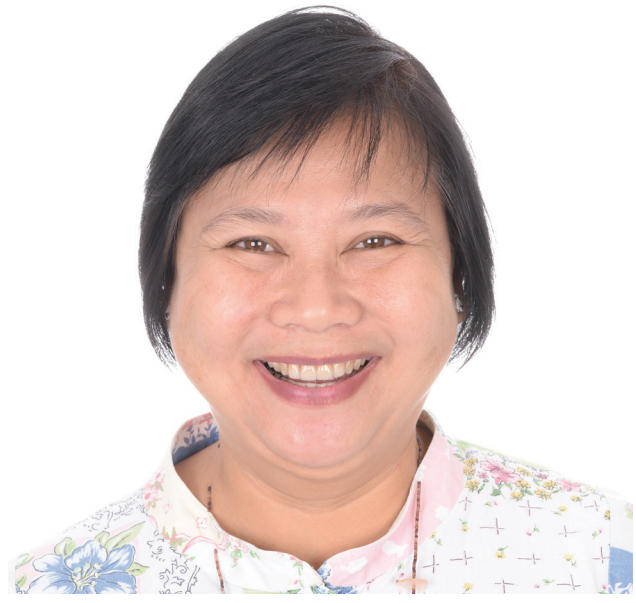
**Figure 18:** Postoperative full-face smile view. The patient's smile looks very natural and in harmony with her face.

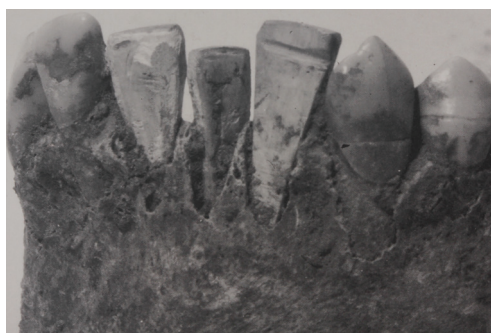
**Figure 3:** First dental implants.

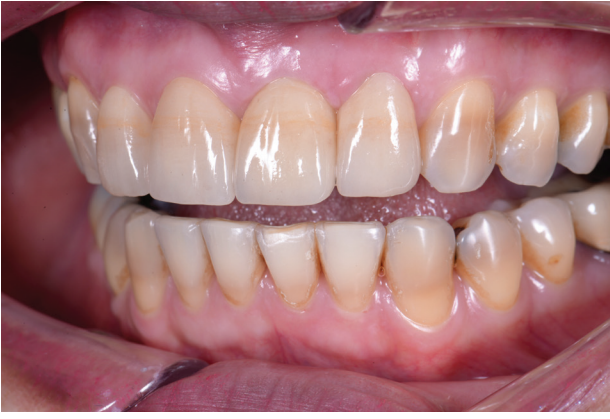
Figure 4: Slightly long contacts due to papilla height.

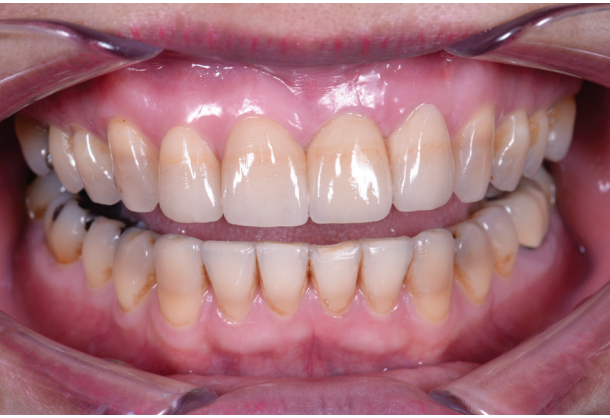
Figure 5: Note contralateral tooth size.
