Using the Erbium Laser to Remove Porcelain Veneers in 60 Seconds

Minimally Invasive, Efficient, and Safe

Glenn A. van As, DMD

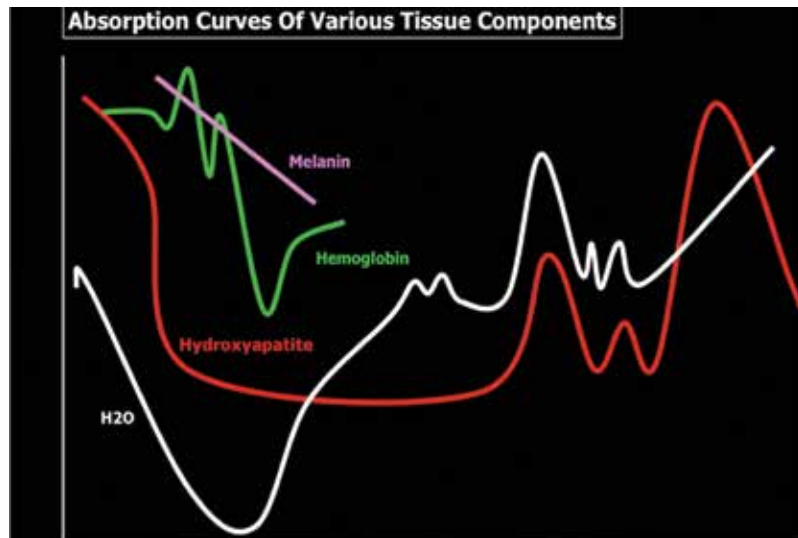
Figure 1: Absorption curve of various tissue components in the four major dental wavelengths. Erbium laser wavelengths are well absorbed in water and hydroxyapatite.

The erbium family of lasers exists between 2,780 nm (erbium, chromium:yttrium scandium-gallium-garnet [Er:CrYSGG]) and 2,940 nm (erbium:yttrium-aluminum-garnet [Er:YAG]). These wavelengths are well absorbed in water and hydroxyapatite (Fig 1), and their absorption in these tissue compounds makes it possible to ablate both soft tissue and hard tissue compounds, which both consist partially of water. Enamel has 6% water, bone has 22% water, and soft tissue is composed of approximately 80% water. The mechanism of action of ablation with erbium lasers, as proposed by Fried,²⁶ is that the erbium laser wavelengths are absorbed in water molecules and cause a rapid expansion of these molecules. The rapid expansion causes micro-explosions, and this, in turn, creates an ablation crater of 200 to 300µm in hard tissue (Fig 2).

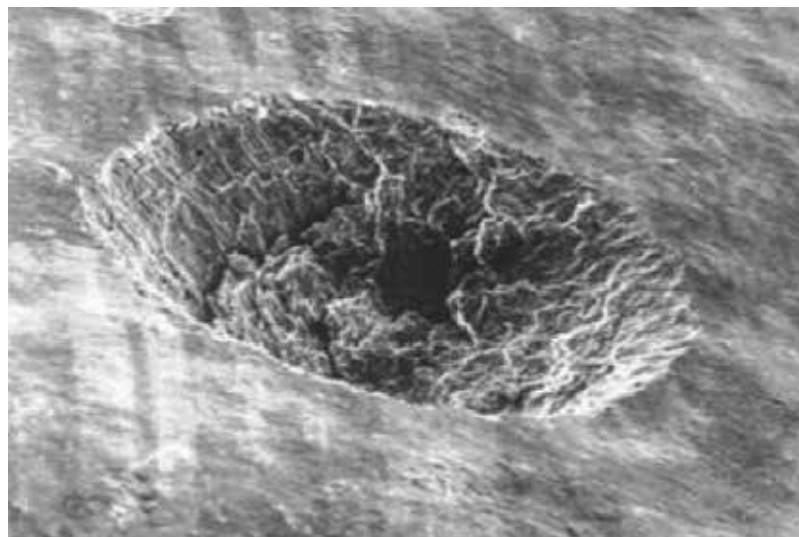
Figure 2: An approximately 200-300µm deep ablation crater made by multiple pulses from an erbium laser. (This image is the property of Peter Rechmann, DMD, PhD, Dr. med. dent., School of Dentistry, University of California San Francisco).

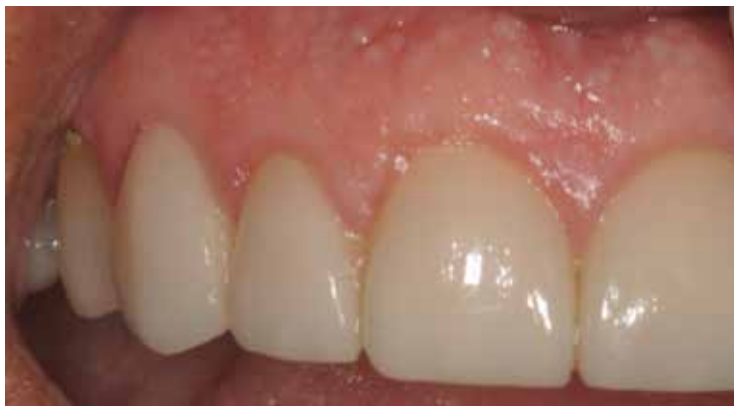
Figure 5: Preoperative view of e.max lithium disilicate veneers.

In this case, a 52-year-old male patient had fractured the distal incisal edge of an e.max porcelain lithium disilicate veneer on his maxillary right lateral incisor. The final restoration had been placed just three months earlier. Treatment options were discussed with the patient; the decision was made to remove and replace the veneer, as the patient was trapping food interproximally and he found the small chip was rough to his tongue and was shredding floss (**Figs 5 & 6**). The Hoya ConBio (Fremont, CA) Er:YAG laser (2,940 nm) wavelength was used at a setting of 10 Hz and 100 mj (compare with Morford et al., who used 10 Hz but 133 mj)⁴² with no water spray for 40 seconds on the facial surface and 10 seconds on the lingual surface. The veneer was removed with one downward pull using a crown and bridge remover. The veneer was intact (**Figs 7 & 8**); afterwards, diode laser troughing was used for tissue management and a final polyvinylsiloxane (PVS) impression was taken (**Figs 9 & 10**). The new porcelain veneer was bonded into place 10 days later. (**Fig 11**).

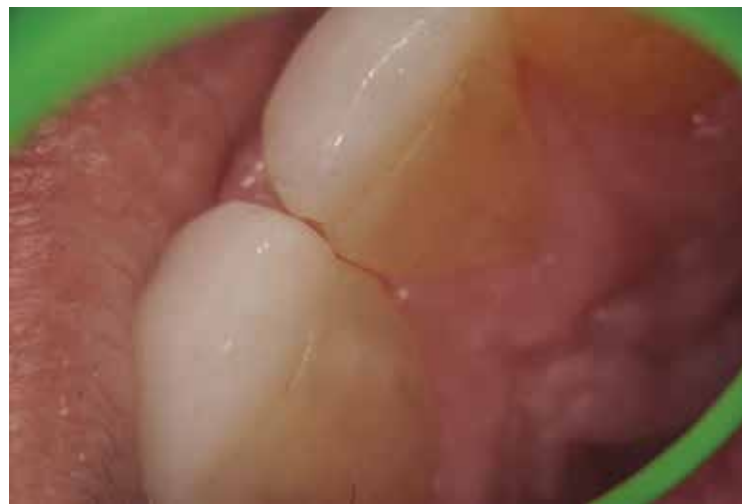
Figure 6: Incisal view of a slight interproximal fracture on the distal incisal embrasure of a lateral incisor.

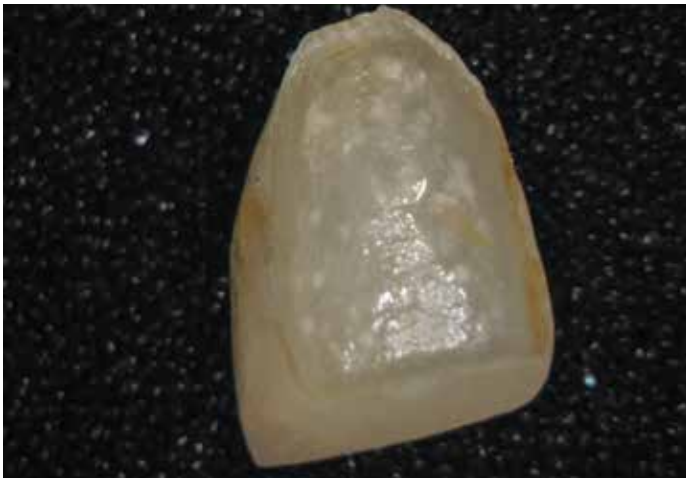
Figure 7: Intaglio (lingual) view of a veneer removed with an Er:YAG laser. Note the intact nature of the veneer.

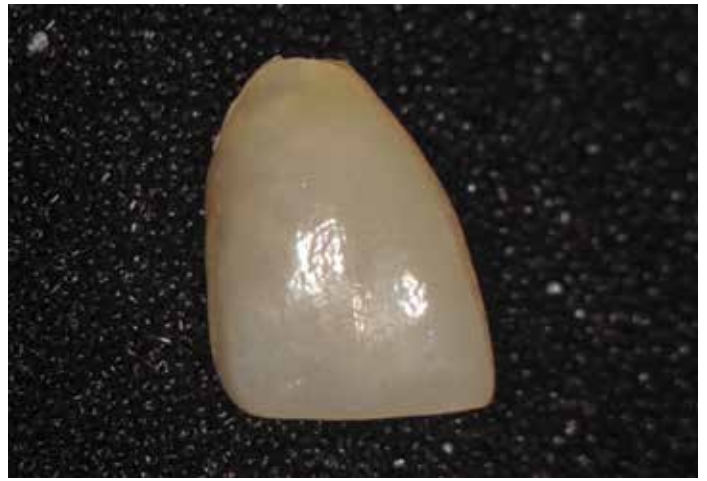
Figure 8: Facial view of the same veneer after removal using an erbium laser.

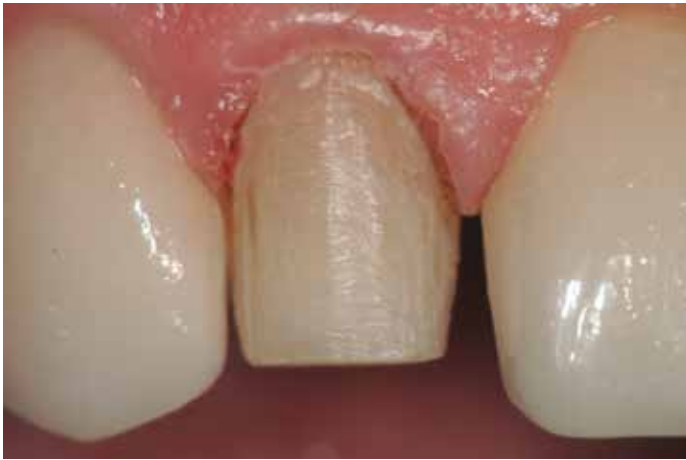
Figure 9: View after completion of diode laser troughing for tissue management.

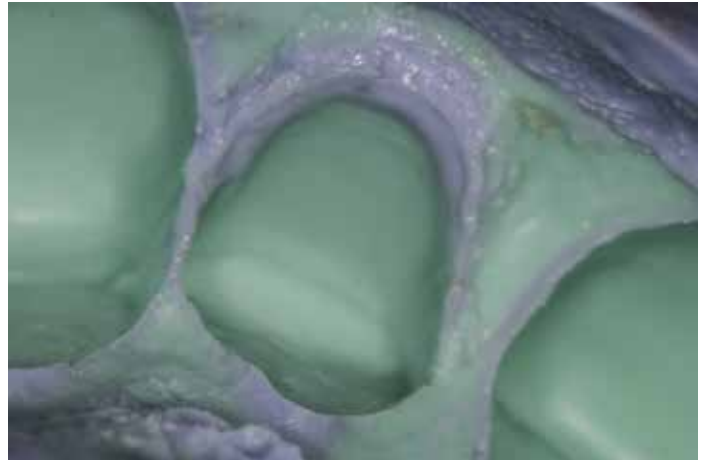
Figure 10: PVS impression of a veneer margin at high magnification.

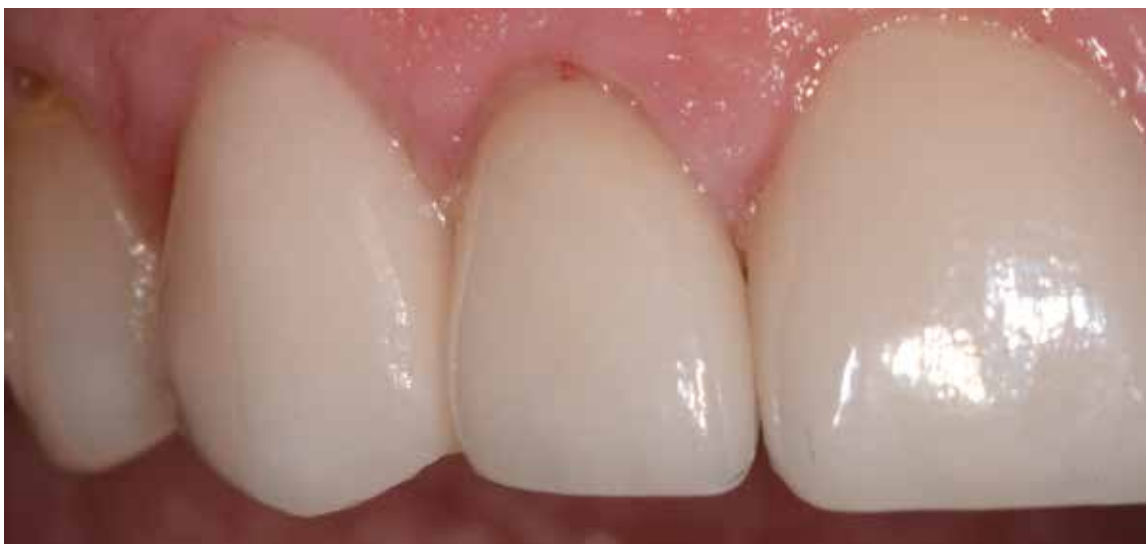
Figure 11: Facial view of a completed veneer immediately postoperative.

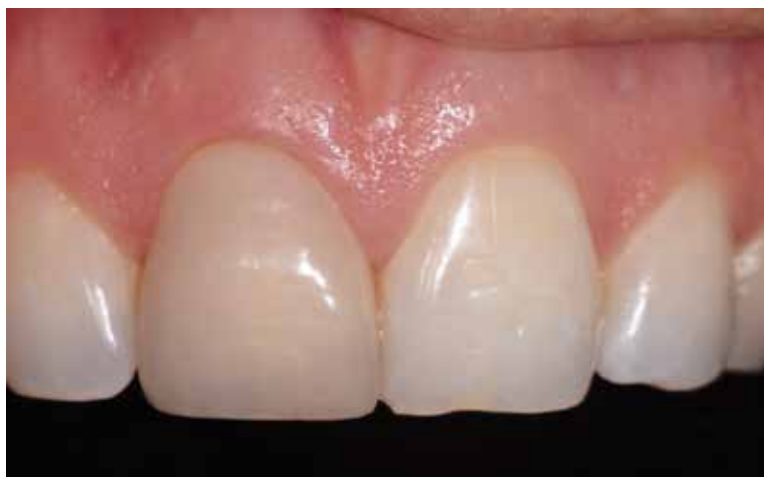
Figure 12: Preoperative appearance of an old porcelain veneer on the right central incisor that is discolored and does not match the adjacent incisor.

In this case, a 37-year old female patient wanted to have a discolored maxillary right central porcelain veneer replaced (**Fig 12**). Treatment options were discussed with the patient; the decision was made to remove and replace the veneer and try to create a better color match to the left central incisor. The Hoya Con-Bio Er:YAG laser (2,940 nm) wavelength was used at a setting of 30 Hz and 200 mj (compare with the 50 Hz and 100 mj used by Oztoprak et al.) accompanied by a fine water spray for 30 seconds on the facial surface and 10 seconds on the lingual surface. The veneer was removed after several downward pulls with a crown and bridge remover. The clinician should extend care when using mechanical means of removing restorations after the laser is used. Ideally, a small overhang in one area will help provide a "catch," whereby the clinician may remove the loosened restoration via a controlled, downward pull. The retained resin cement was visualized on the preparation (**Fig 13**). Due to the excessively aggressive previous preparation into dentin as well as the lingual decay (**Fig 14**), the decision to fabricate a full e.max lithium disilicate crown was made (**Fig 15**). The new porcelain restoration was bonded into place 10 days later (**Figs 16 & 17**).

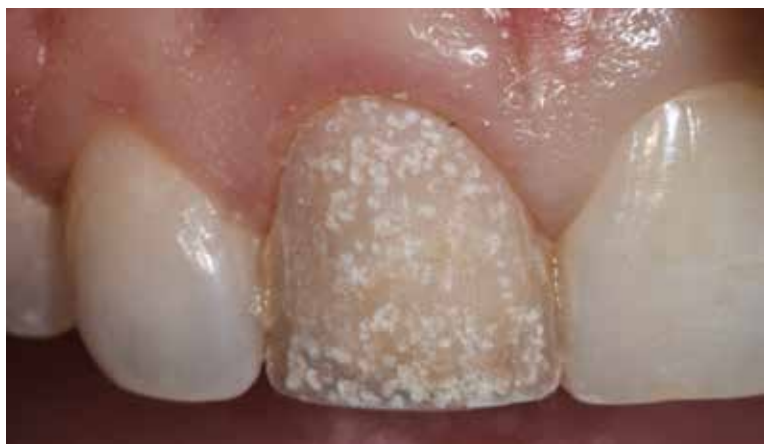
Figure 13: Immediate appearance after the veneer was removed with an Er:YAG laser.

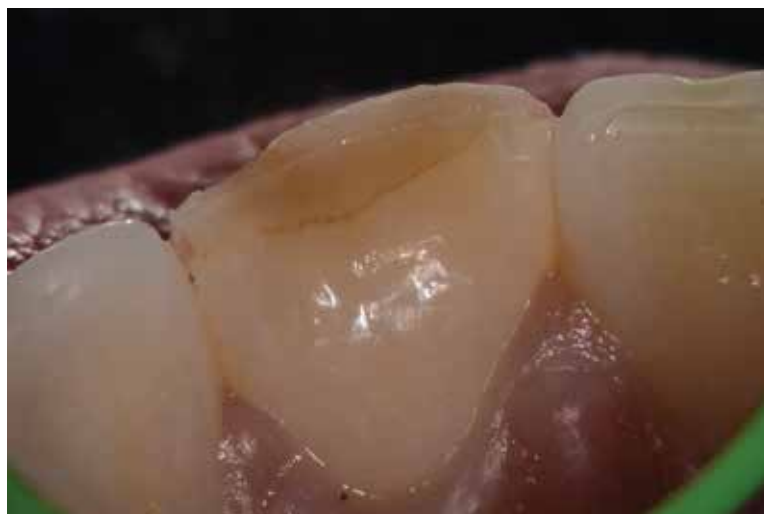
Figure 14: View of the lingual surface shows decay and old resin requiring full-coverage crown preparation instead of a veneer preparation.

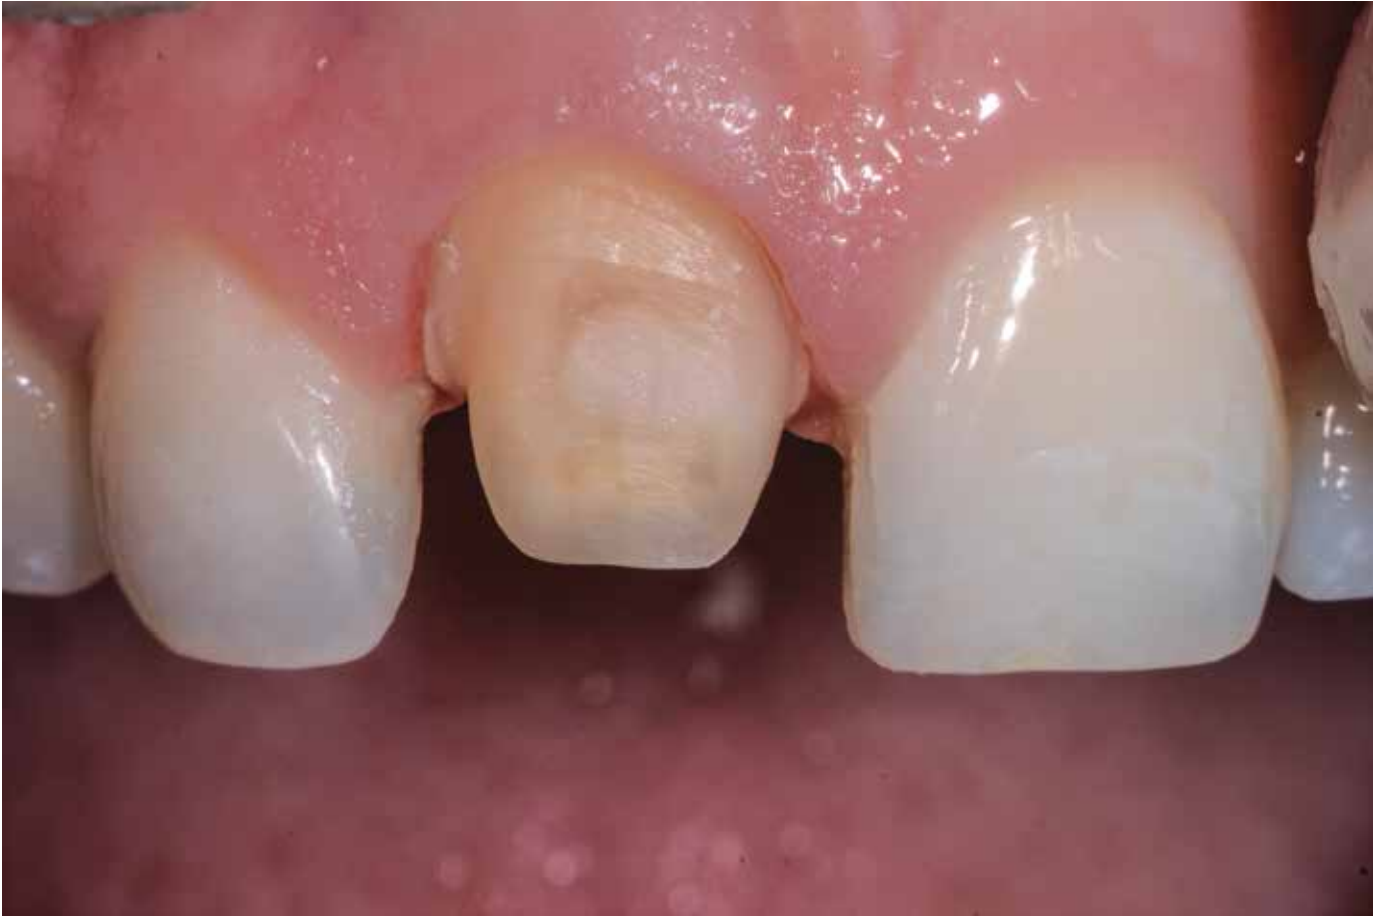
Figure 15: Full-coverage preparation for a right central incisor with an e.max lithium disilicate crown.

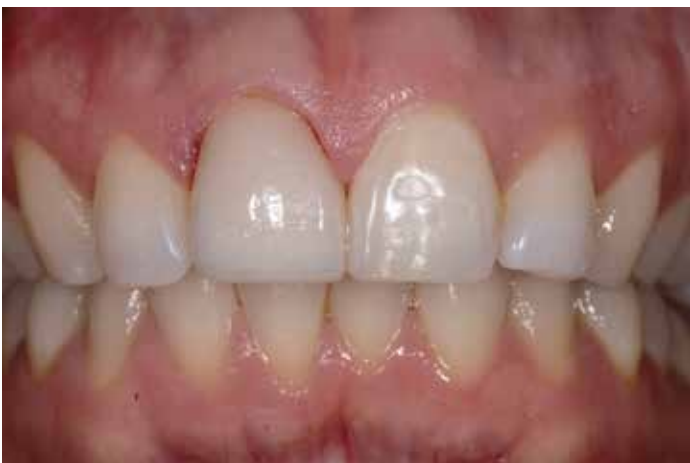
Figure 16: Immediately postoperative appearance of a bonded e.max crown.

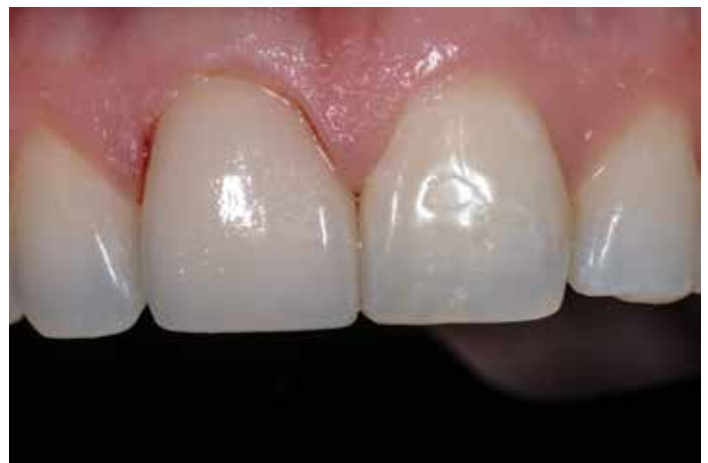
Figure 17: Immediately postoperative close-up view of a right central incisor crown.

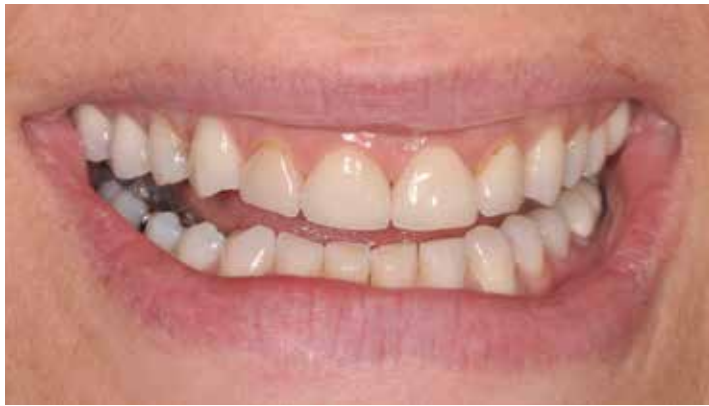
Figure 18: Preoperative appearance of "short" porcelain veneer preparations with poor length-to-width ratios that make the teeth appear square.

In this case, a 35-year-old female patient wanted to have short, leaking, and discolored veneers replaced on her maxillary anterior incisors (##7-10) (Fig 18). Treatment options were discussed with the patient. The decision was made to remove and replace only the maxillary central and lateral incisor veneers due to financial considerations; therefore, the buccal corridor (canines and premolars) were not treated. In addition to replacing the failing restorations, the patient wanted to make the teeth longer. A "laser smile lift" or closed flap crown lengthening was performed with an Er:YAG laser to make the teeth longer.

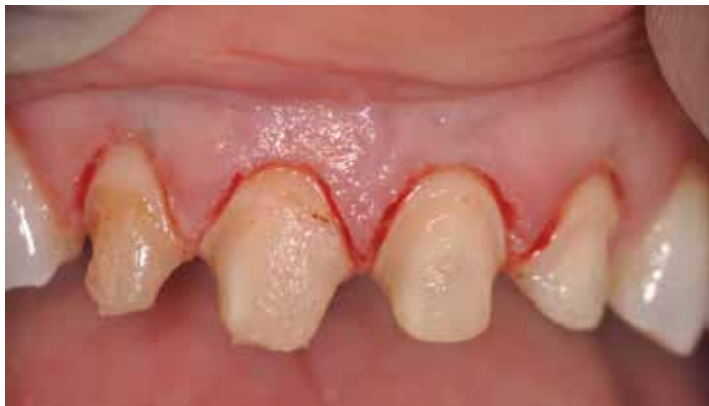
Figure 19: View immediately following completion of a laser crown-lengthening procedure and removal of veneers on all four maxillary incisors.

The Hoya ConBio Er:YAG laser (2,940 nm) wavelength was used at a setting of 30 Hz and 40 mj (1.2 W) with a fine water spray to recontour first the soft tissue and then to correct the resultant biologic width problems. The resultant crown preparations are shown in Figure 19. The veneers were removed with settings of 30 Hz and 175 mj (5.25 W) in 30 to 60 seconds.

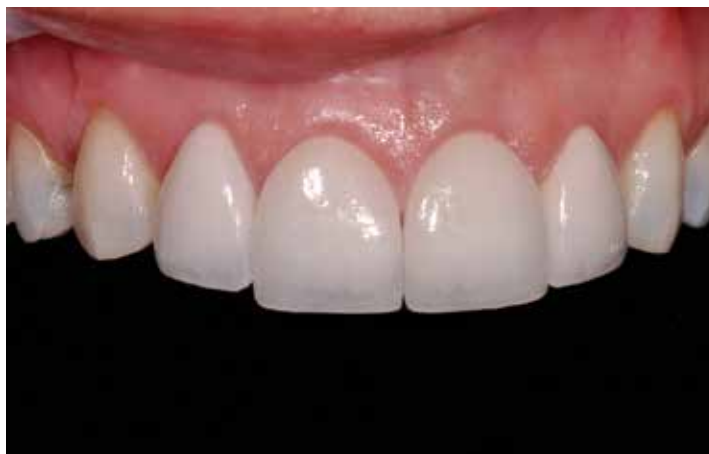
Figure 20: Postoperative view of new e.max lithium disilicate crowns in place with an improved width-to-length ratio.

The decision to fabricate full-porcelain IPS Empress Esthetic crowns was made. The new porcelain restorations were bonded into place later, and the immediate postoperative appearance can be seen in Figures 20 and 21.

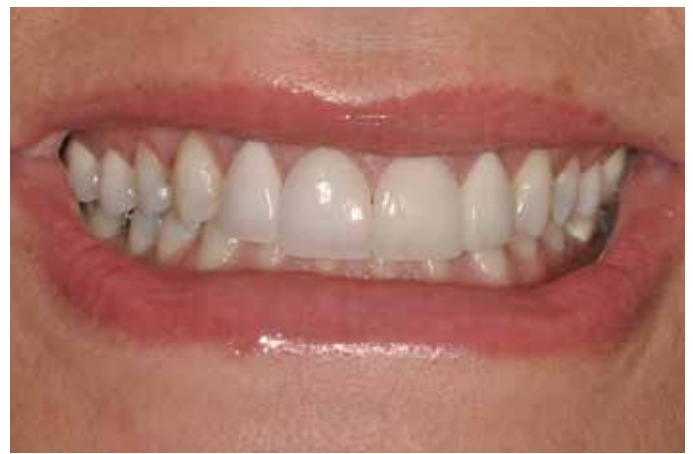
Figure 21: Note the improved smile appearance after new restorations were placed compared to the preoperative view.

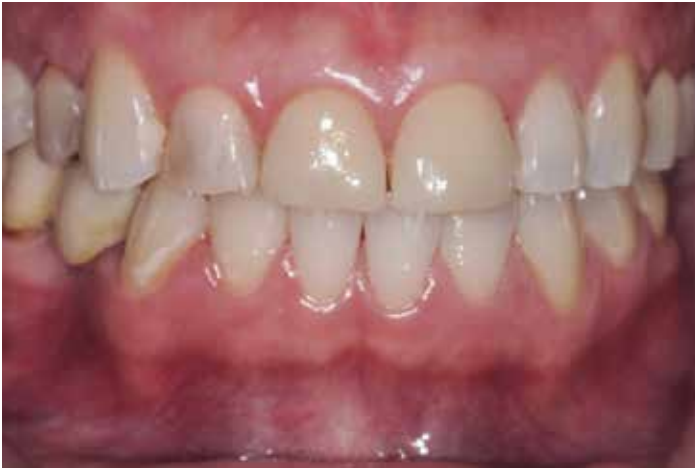
Figure 22: Preoperative view of the retracted smile prior to the "makeover."

A 40-year-old female patient wanted to pursue a "smile makeover." Her extensively restored anterior maxillary dentition from her first premolar to first premolar had numerous failing and discolored composite restorations. The patient received eight lithium disilicate (e.max) crowns placed on ##5-8 (##14-11 international) and ##9-12 (##21-24 international). After the final restorations were bonded into place, the patient developed irreversible pulpitis on the maxillary right lateral incisor and endodontic therapy was required.

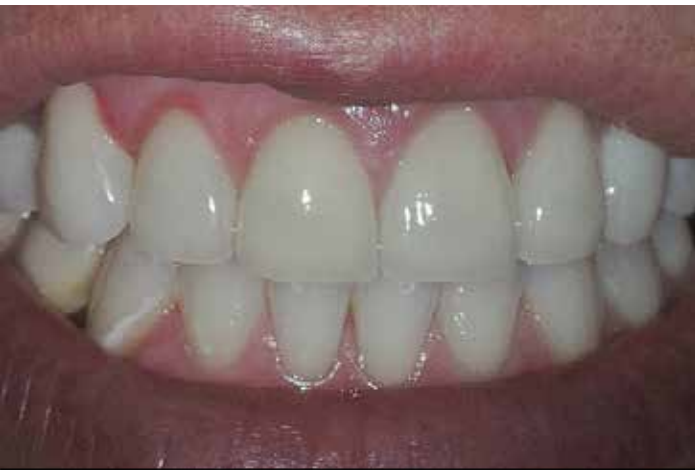
Figure 23: The patient had irreversible pulpitis on the right maxillary lateral incisor and was unhappy with "spots" seen under final incisor e.max crowns.

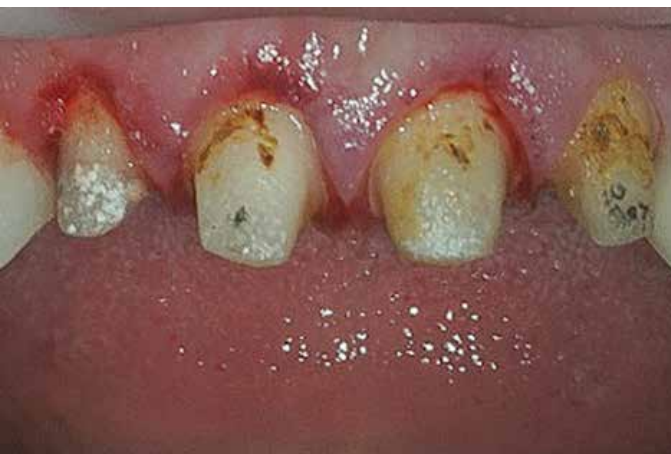
Figure 24: View after root canal therapy and laser removal of the lithium disilicate crowns were completed; note the "brown spots" of uncured resin cement on incisor preparations.

The lithium disilicate crown was removed with an Er:YAG laser used for two minutes (60 seconds on the facial and lingual surfaces, with settings of 30 Hz and 200 mj; 6 W with air/water- spray). The endodontic therapy was completed on the tooth. Subsequently, the remaining three incisor crowns were also removed using the Er:YAG laser with similar settings. The patient had noticed "brown spots" on the facials of these teeth, which turned out to be uncured resin cement showing through. The patient's restorations were replaced, and the new lithium disilicate crowns were bonded into place (Figs 22-26).

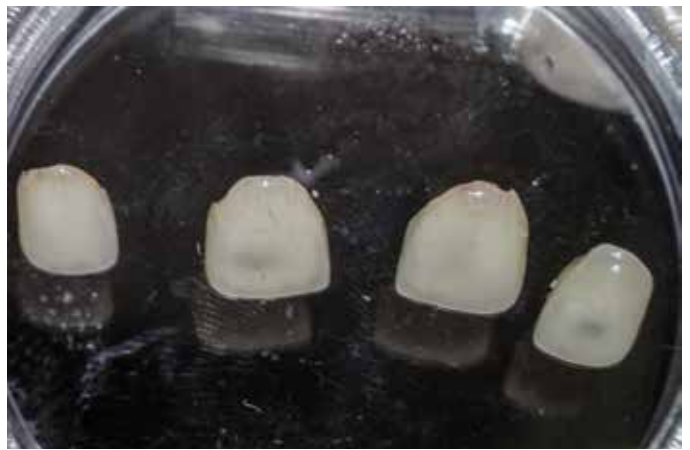
Figure 25: Four e.max crowns were removed via laser and sent back to the laboratory.

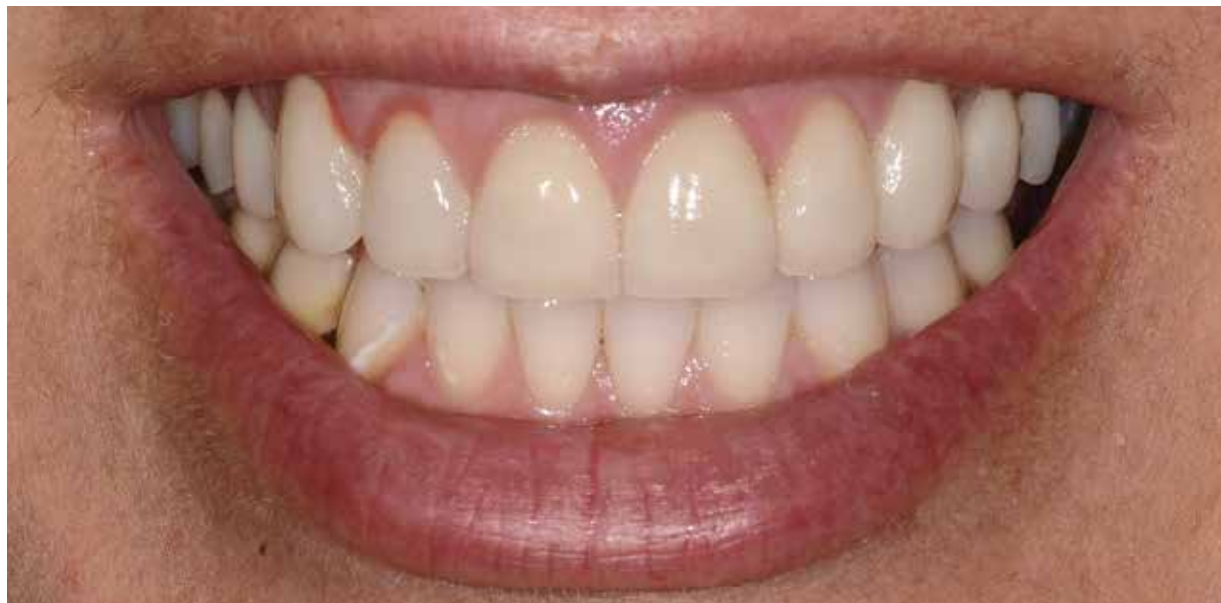
Figure 26: Final view of the patient's smile after placement of new e.max crowns fabricated at the laboratory.
