Communication and Artistry in Case Type II

James H. Peyton, DDS, FAACD

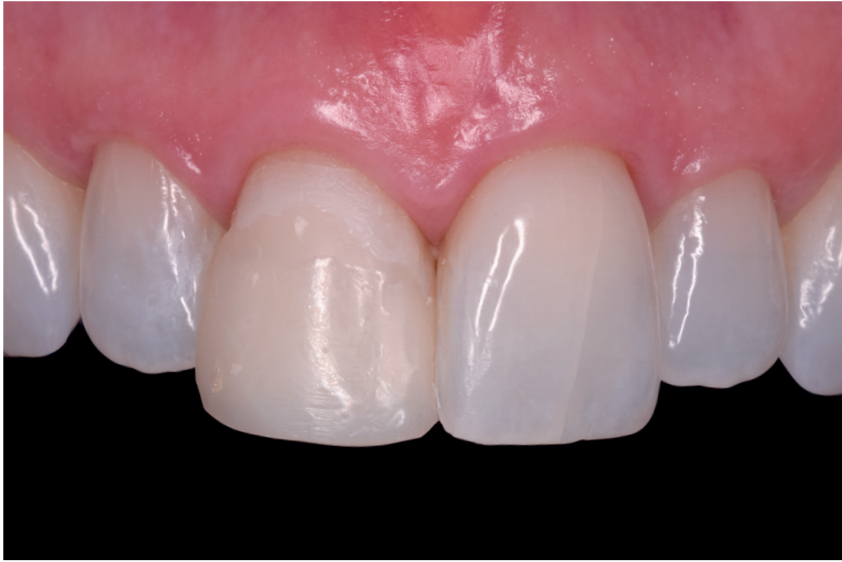
Figure 1: The preoperative 1:1 view, showing an old composite restoration that is over contoured and discolored.

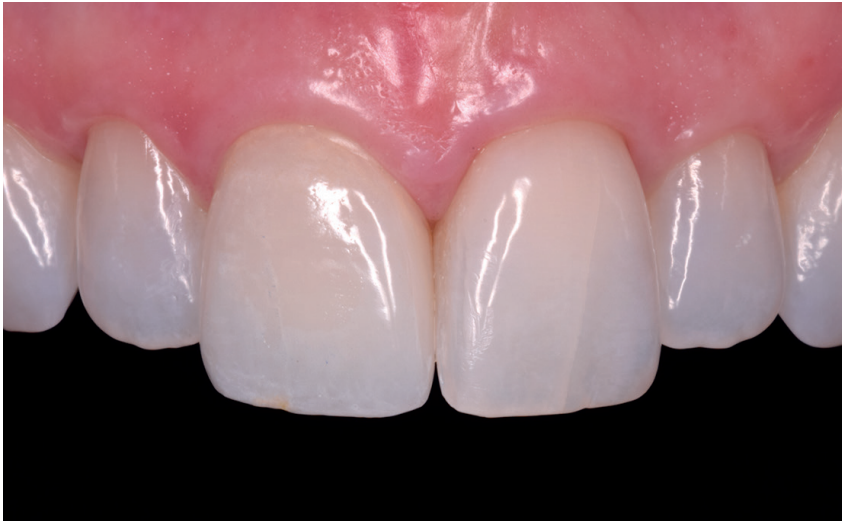
Figure 2: The postoperative 1:1 view, displaying extremely well-matched central incisors.

- **Criterion 53:** *Is the color (hue, value, chroma) selection appropriate/natural, not monochromatic?* Several examiners felt that the restoration was higher in value than the adjacent natural tooth. However, the restoration had increased chroma in the cervical third.
- **Criterion 61:** *Is margin placement and design appropriate? Are the margins visible?* Several examiners felt that the margin was visible on the 1:1 view.
