Tips for Preventing a Visible Fracture Line in a Class IV Composite

James H. Peyton, DDS, FAACD
Brian J. Gilbert, DDS, AAACD

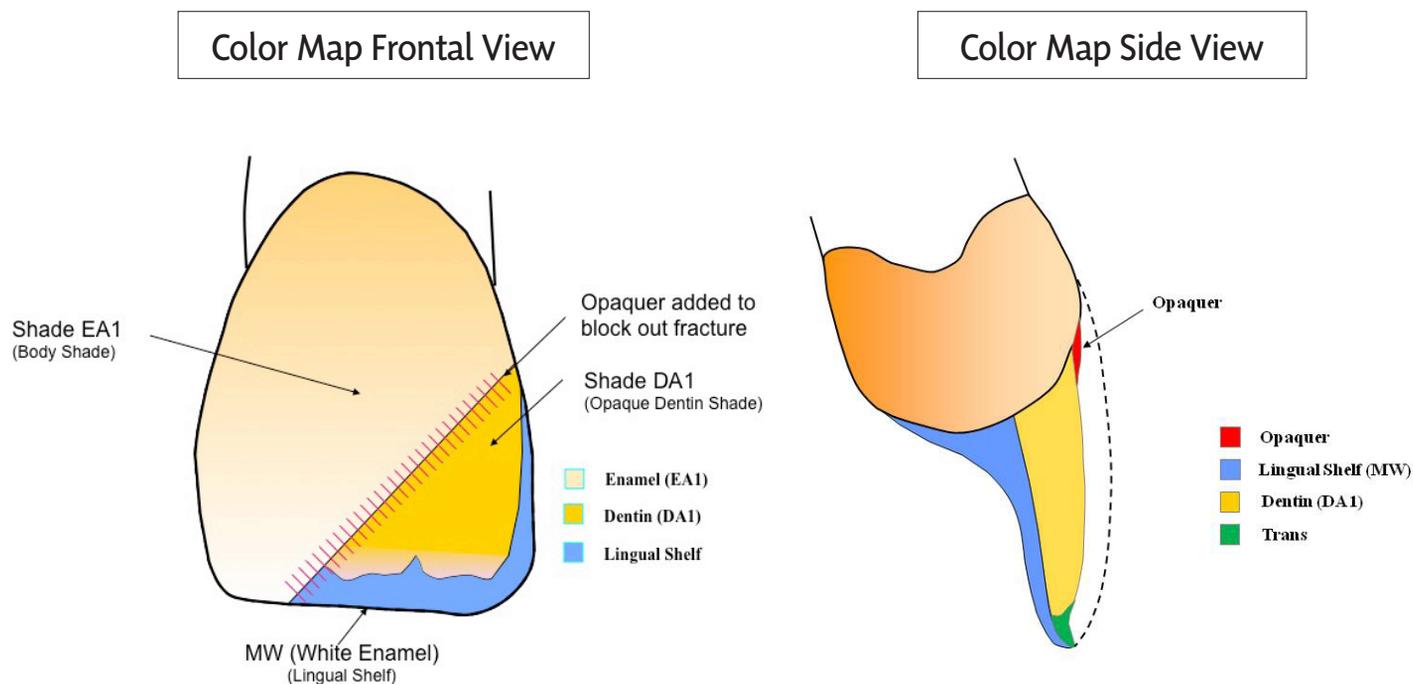
Figure 1: The frontal view color map shows the fracture line, the location of the dentin, and where to add an opaquer if necessary.

Figure 2: The side view color map shows the placement of the opaquer on the fracture line (usually right at the dentinoenamel junction).

When retreating a Class IV composite, typically the entire old restoration should be removed. Before removing it, make sure the lingual contour of the old restoration is ideal by reshaping and/or mock-up bonding the area and then make a quick putty matrix of the lingual surface of the tooth up to and including the incisal edge. Next, choose a dentin shade. Most composite restorative systems come with dentin shades. If there are no dentin shades, use an enamel body shade one to two chroma higher than the selected enamel shade. For example, if the enamel shade is A1, select A2 or A3 for the dentin shade (Figs 1 & 2).^{1,2}

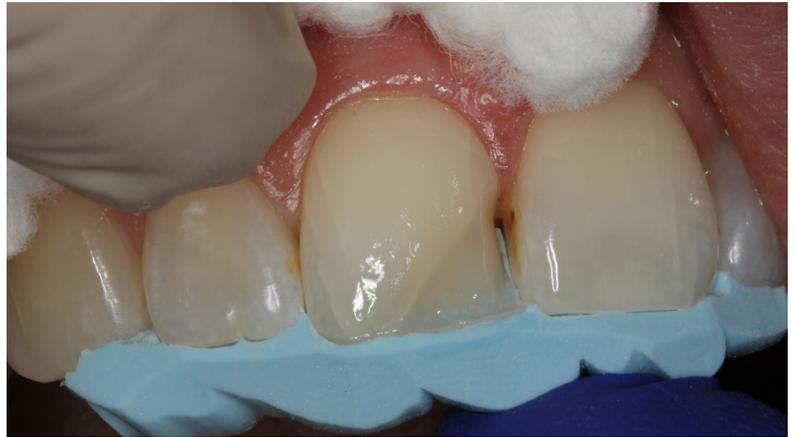
Figure 3: After the dentin shade of composite was added there was a visible fracture line.

After light-curing, check to see if a line is visible. If one does not appear, then there will not be a visible fracture line in the completed restoration. If a line exists, then either the dentin shade was incorrect (i.e., too translucent or not the correct value), or there was not enough volume/thickness of the dentin shade. If the dentin is correct in volume and placement, the clinician has two choices: start over with a different dentin shade or use an opaquer to blur the fracture line and make it disappear (e.g., Creative Color Opaquers [Cosmedent; Chicago, IL], Kolor Plus [Kerr; Orange, CA], or Estelite Color [Tokuyama Dental; Encinitas, CA]). To apply the opaquer, use a small brush (size 1, Art Store, Tokuyama, or Cosmedent) and add a small amount to the fracture area in incremental coats until the fracture disappears. Next, apply the enamel shade and finish and polish the restoration.^{4,5}

If these steps are followed the final results should be a Class IV restoration without any sign of a fracture line...and a happy patient (Figs 3-6).

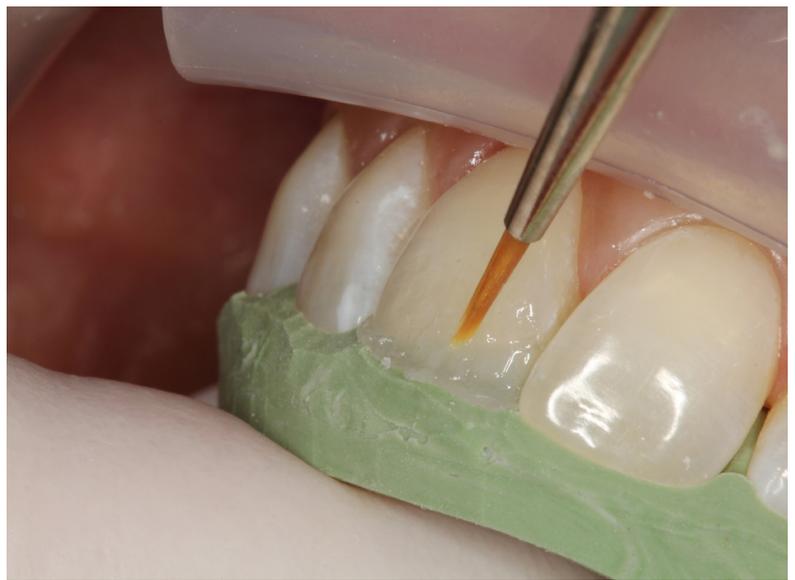
Figure 4: The opaquer was added to mask out or blur the visible fracture line.

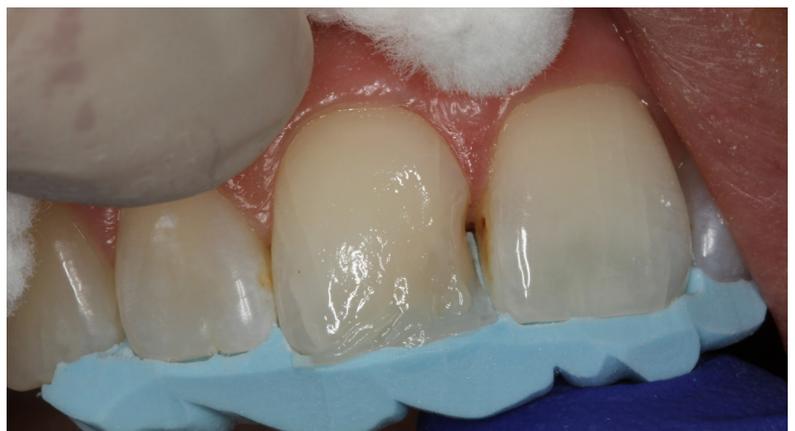
Figure 5: The fracture line disappeared after the opaquer was added.

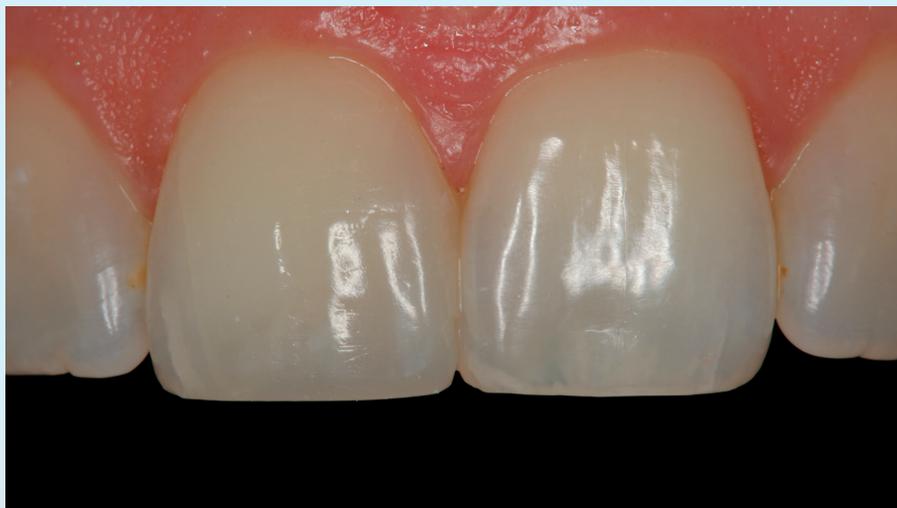
Figure 6: The finished restoration shows no evidence of a fracture line.
